## STANDARDS FOR REHABILITATION & GUIDELINES FOR REHABILITATING HISTORIC BUILDINGS

# Rehabilitation

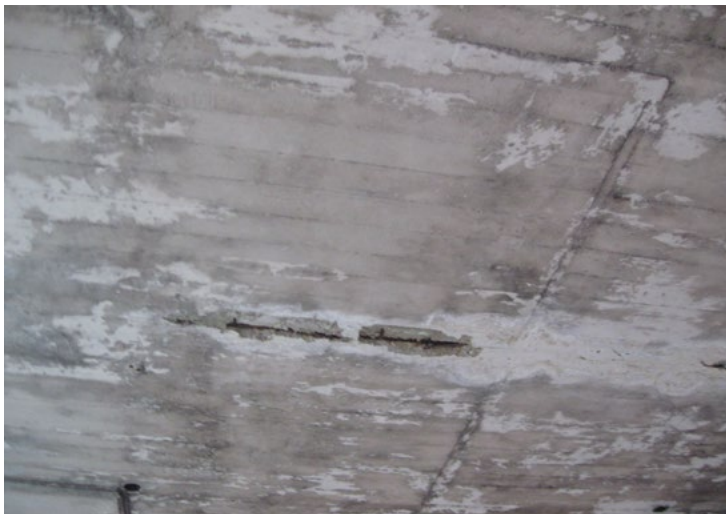
[5] Rebars in the reinforced concrete ceiling have rusted, causing the concrete to spall. The rebars must be cleaned of rust before the concrete can be patched.

| Cutting damaged concrete back to remove the source of deterioration, such as corrosion on metal reinforcement bars. The new patch must be applied carefully so that it will bond satisfactorily with and match the historic concrete. | Patching damaged concrete without removing the source of deterioration. |

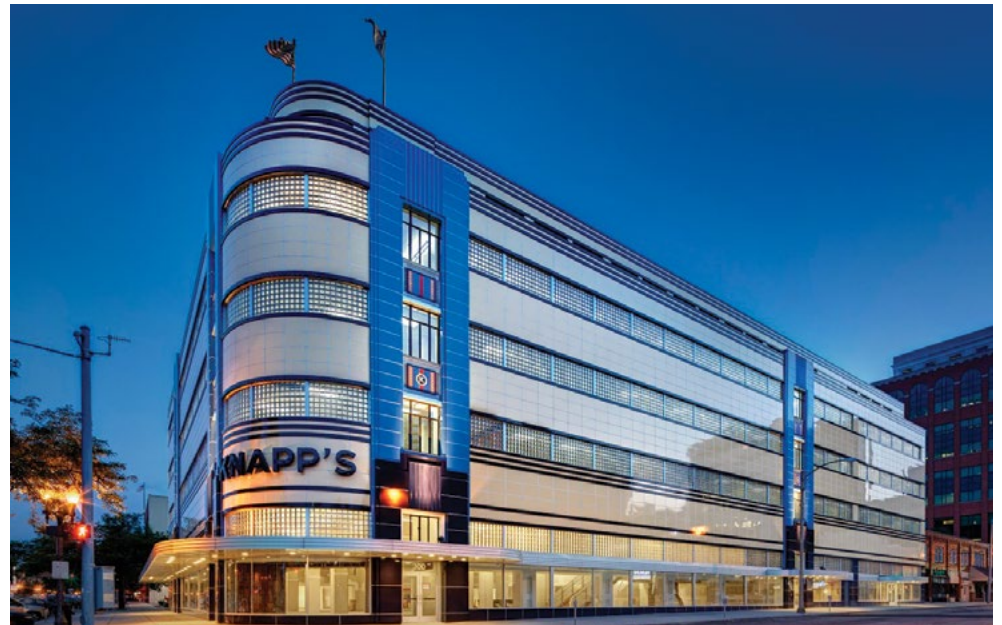
[7] (a) J.W. Knapp's Department Store, built 1937-38, in Lansing, MI, was constructed with a proprietary material named "Maul Macotta" made of enameled steel and cast-in-place concrete panels. Prior to its rehabilitation, a building inspection revealed that, due to a flaw in the original design and construction, the material was deteriorated beyond repair. The architects for the rehabilitation project devised a replacement system (b) consisting of enameled aluminum panels that matched the original colors (c). Photos and drawing (a-b): Quinn Evans Architects; Photo (c): James Haefner Photography.

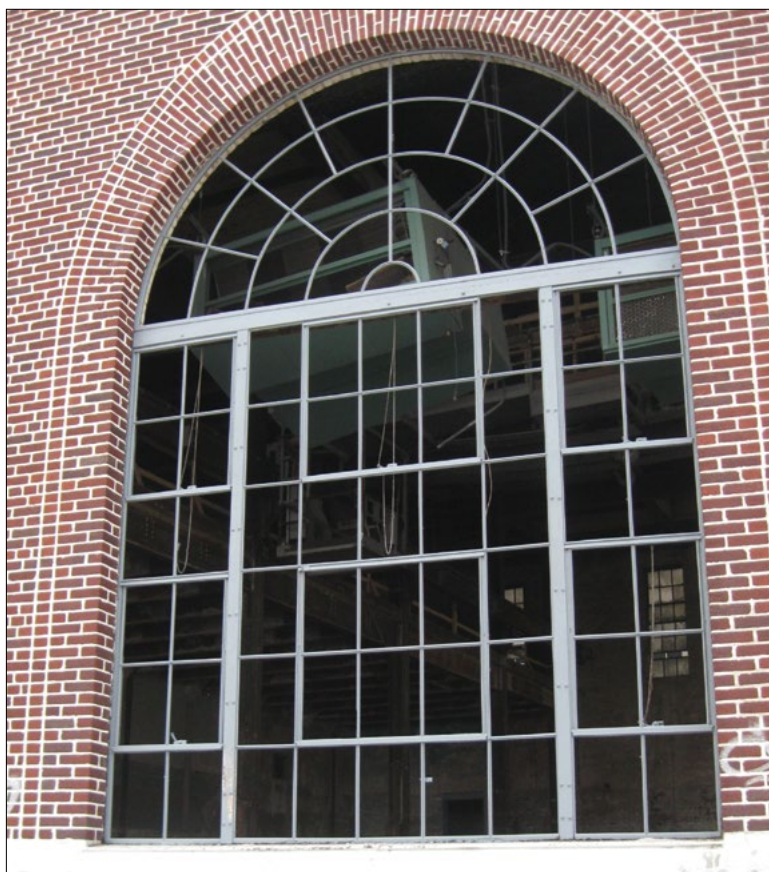
[12] This historic steel window has been cleaned, repaired, and primed in preparation for painting and reglazing.

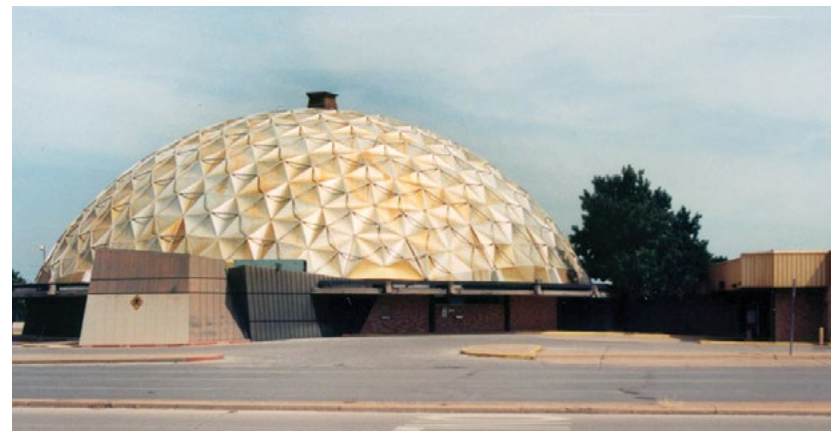
[13] The gold-colored, anodized aluminum geodesic dome of the former Citizen's State Bank in Oklahoma City, OK, built in 1958 and designed by Robert Roloff, makes this a distinctive mid-20th century building.

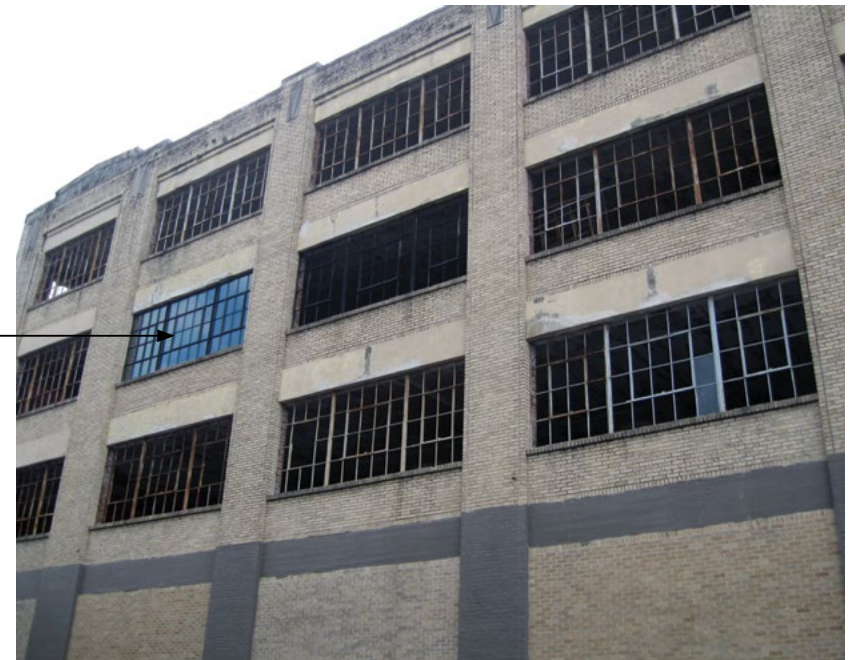
[19] Installing a mockup of a proposed replacement window can be helpful to evaluate how well the new windows will match the historic windows that are missing or too deteriorated to repair.

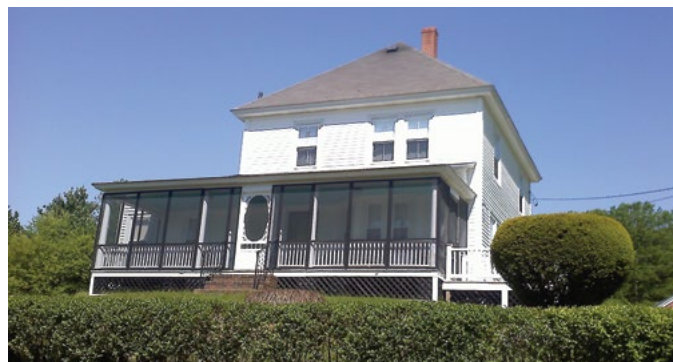
[26] **Not Recommended:** Installing a screened enclosure is never recommended on a front or otherwise prominent historic porch. In limited instances, it may be possible to add screening on a porch at the rear or on a secondary façade; however, the enclosure should match the color of the porch and be placed behind columns and railings so that it does not obscure these features.

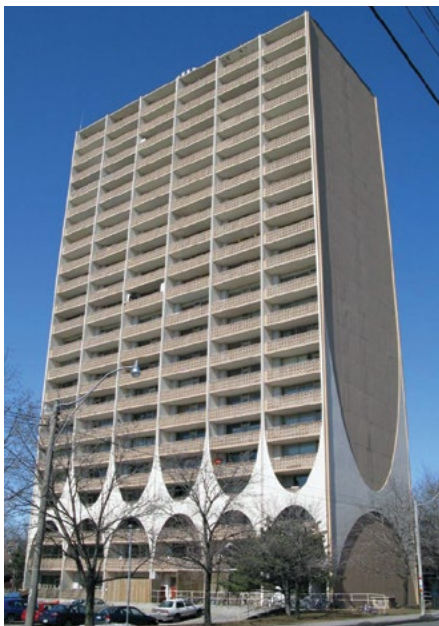
[59] (a-b) The decorative concrete balcony railings on this 1960s building did not meet life-safety code requirements. They were replaced with new glass railings with a fritted glass pattern matching the original design—a creative solution that satisfies codes, while preserving the historic appearance of the building when viewed from the street (c-d). Photos: (a, b, d) ERA Architects, Inc.; (c) Nathan Cyprys, photographer.
